# Safe at Home Repair Evaluation Report

CLIENT:	[REDACTED]	Phone:	[REDACTED]
ADDRESS:	[REDACTED]	Cell:	[REDACTED]
Age/Description of House:	1965, split level brick SF w/ decorative porch, den on 1 <sup>st</sup> floor, laundry room on first floor, bedrooms, kitchen and living areas on 2 <sup>nd</sup> floor. Clients use front door exclusively (1 <sup>st</sup> floor). House was restained 9/2011. Generally excellent condition.	Initial Inspection?	Yes
Occupant Issues:	Clients state no physical limitations, mostly upkeep issues. Recent balance/tripping problems, transition between bedroom and bathroom. Bathrooms have been partially modified, kitchen recently remodeled.	Home Audit	Yes (link disabled)
Other Info:	No pets, occupants do not smoke, no mobility assistance used

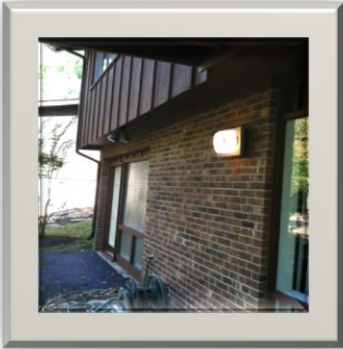
<p>2 exterior entry lighting</p>	Lighting – single address light original to house, malfunctioning motion detector over den entry	Minimal – needs to be increased	Improve entrance exterior lighting, repair motion detector	10/27/11 repaired and tested motion detector, increased wattage in address light  Recommend additional light above door - discuss with client

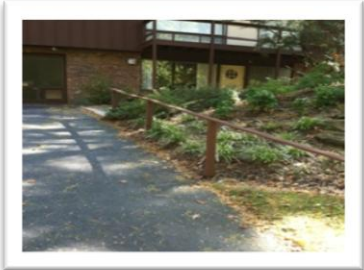
<p>3 path from beginning of driveway</p>	Handrails – wooden rail along driveway, ends at flagstones	Originally installed by Safe at Home, still in good condition		
	Landscaping/ Visibility	Excellent – nothing	Landscaping is well-maintained

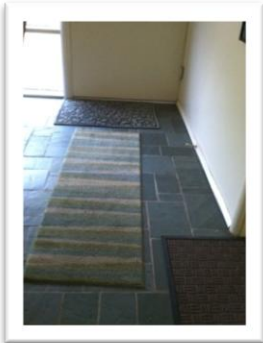
4 Inside front door

Mail slot in door is plugged daily to keep out cold, three walk-off mats before staircase.	Recommended removing all but single heavy duty walk off matt inside front door	Removed 10/27/11
	<b>Side Entrance - not used</b>	Appearance	Some trash along fence line	Removed 10/27/11
		Landscaping &	Fine

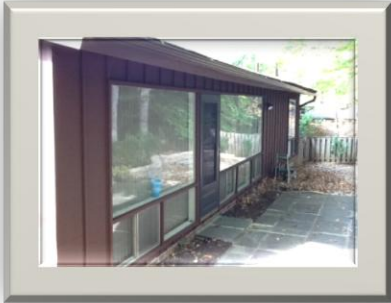
5 Rear Entrance

Access	2 steps down to patio	Back entrance rarely used	
	Security	2 locks	Both were secure at visit	
	Hand Rails	None		
	Lighting	Needs exterior	Recommend exterior floodlight, switch inside

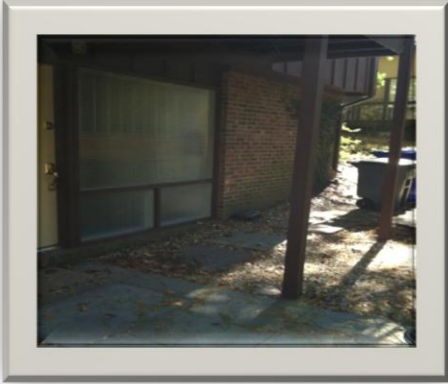
<p><b>6 TRASHCAN/RECYCLING STORAGE AREA</b></p>	<p>Location, Access is poor</p> <p>Must be wheeled over uneven rocks, flagstone, over raised bed threshold, down steep driveway to grassy area adjacent to driveway, one at a time, every week.</p>	<p>1 large trashcan, 1 large recycling, both wheeled with handles.</p>	<p>Could build 2-walled shed to left of house, alongside den wall. Will eliminate half distance of wheeling full cans. Would need to level floor. But then presents longer walk to eliminate daily trash bags. Further discuss with client.</p>	<p>Discussed with Client – will consider as long-term project</p>

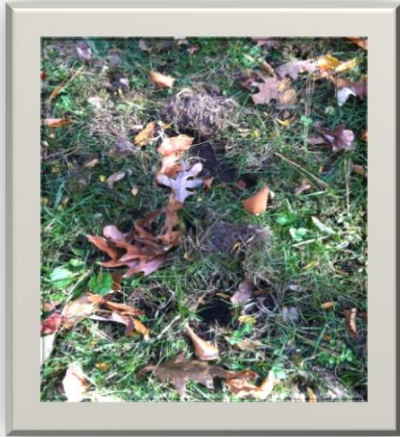
7 Raccoon damage in side yard

<p>Steep Hill in front yard. Has weekly lawncutting service w/ Rick's Lawn Service, 301-540-4798</p> <p>Neighbor and/or family handles snow removal</p>	<p>Some raccoon damage to side yard, client wants abated asap</p>	<p>Discuss w/ landscaper</p>	<p>Met w/Dale Moyer (Moyer Landscaper) 10/18/11 7:30 am – 10/21 Moyer applied grub killer, aerated. 11/19 most raccoon damage is eliminated. Consider re-sod w/ netting in Spring, will provide proposal to MHC</p>
---	---	------------------------------	---

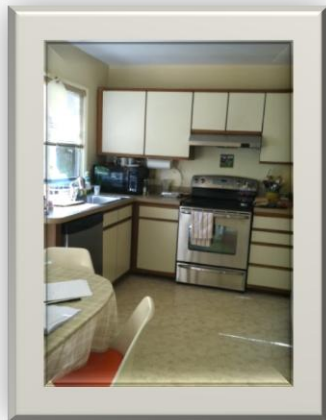
8 Kitchen

Lighting	Adequate lighting in task areas	Clean overhead light fixture of bugs	Done at time of inspection
	Condition of Appliances	Excellent, kitchen remodeled approx. 5 years ago	Very clean, no oven buildup, microwave clean	
	CO Detector – type/location/ battery schedule		Tested ok, but probably 7+ years old, recommend change now and track	Done 10/17/11
	Range clear	Yes		
	Pot Lids close to stove, Timer on counter?	Yes	Discussed stove top safety with client	
	Evidence of Smoke Damage near range	No		
	Emerg #s near phone	Yes in pantry closet		
	Fire Extinguisher	Yes in pantry closet		
	Cabinets	Not modified, client says no issues getting to lower shelves, top

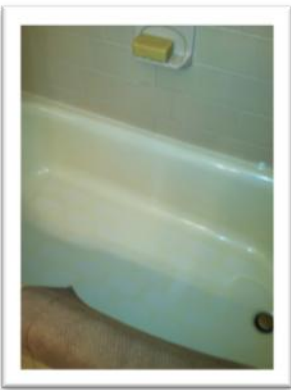
Drainable Tub Mats	No	Need Mat	Customer wants to purchase, check next quarter
<b>9 Master Bath</b>				
	Accessible showerheads	Yes

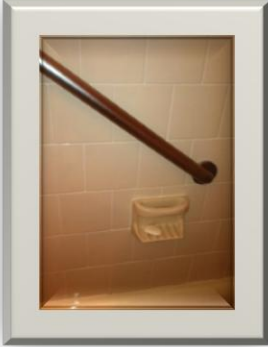
11 2nd upstairs bath

Throw Rugs?		Recommend replace existing with rubber backed	Customer will purchase, check next qtr
	Accessible Shower Head	Yes		
	Drainable Tub Mats		Need Mat	Customer wants to purchase, check next qtr

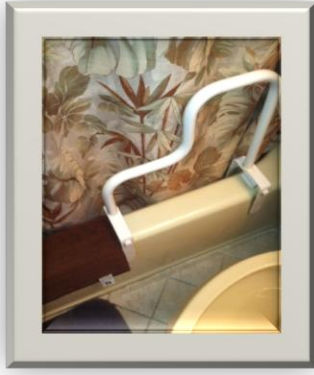
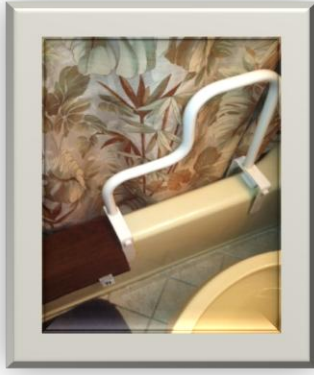
12 2nd upstairs bathroom

<p>12 2nd upstairs bathroom</p>	<p>Grab Bars in and out of bathing area</p>	<p>On far wall and bolted/glued to bathtub edge – client does use</p>	<p>Recommend install vertical bar leading into tub</p>	<p>Discuss again next qtr</p>
	<p>Condition of Fixtures</p>	<p>New</p>		
	<p>Anti-Scald mixers?</p>			
<p>MASTER BEDROOM</p>				
	<p>Throw Rugs?</p>	<p>Rubber backed ok</p>		
	<p>Transition pathway clear?</p>	<p>Clutter near doorway</p>	<p>Eliminate storage of shoes between bedroom and bathroom</p>	<p>Done 10/27/11</p>
	<p>Height of closet rods/shelves</p>	<p>Not an issue</p>		
	<p>Height of bed?</p>	<p>Ok</p>		
	<p>Clothes hooks</p>	<p>Yes and being used</p>

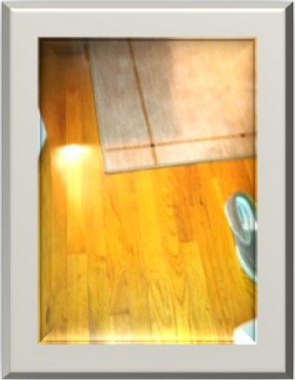
Bedsread length	Ok not trip hazard		
	Need rails/poles?	no		
Bedroom 2 (used)	Throw Rugs	none		
	Need for rails/poles?	No		
	Height of closet rods/shelves	Fine, doesn't use closet in this room		
	Clothes hooks	Yes and being used		
	Bedsread length	Ok not trip hazard		
	Height of bed?	Ok		
	Throw Rugs	Room size rug which may present trip hazard	Advised customer recommend eliminating

13 Bedroom Rug curling				
<b>Basement</b>

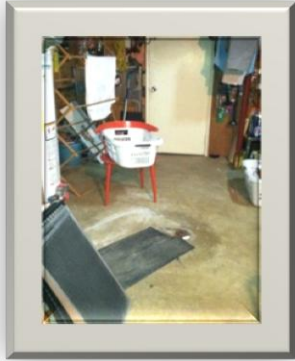
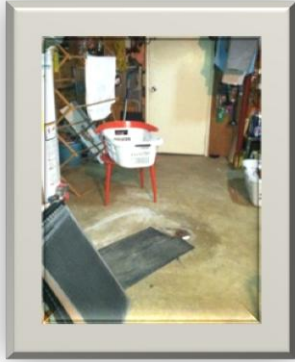
14 Laundry Room

<p>Condition Generally neat, tidy, but not well lit, and major trip hazard as shown, loose basement doorknob.</p>		<p>Increase lighting Consider folding table where chair is, store filters away.</p>	<p>Fixed doorknob at time of inspection  Client wants to discuss other improvements in spring</p>
	<p>Adequate storage for supplies</p>	<p>Shelf next to dryer, uses smaller containers</p>		
	<p>Appliance condition</p>	<p>Excellent</p>		
	<p>Odor</p>	<p>None</p>		
	<p>Evidence of Water Penetration/ Efflorescence</p>	<p>None</p>

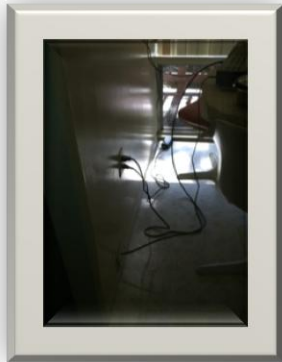
16 Extension cord use in kitchen

Electric cords	Kitchen needs addressing	Bundle cords, consider moving TV to wall bracket?	Revisit next quarter
----------------	--------------------------	---	----------------------

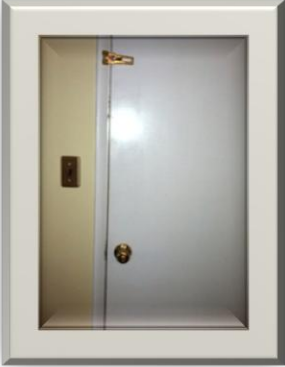
<p>Front Door locks – type and condition</p>	<p>Deadbolt upper, simple non-locking door knob lower</p>	<p>Consider lever for lower</p>	<p>Discussed w/ client – leave as is for now</p>
<p>19 Inside front door</p>

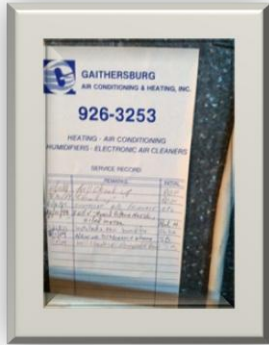
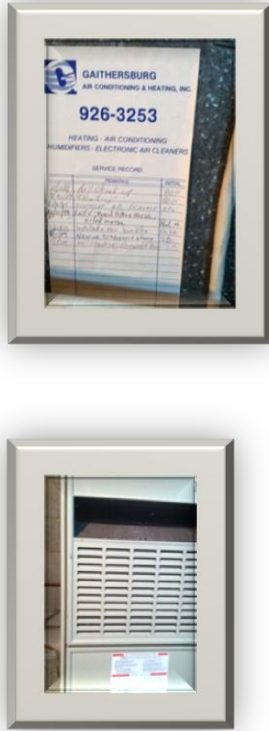
21 HVAC equipment in basement

<p>21 HVAC equipment in basement</p>	<p>HVAC: type/condition</p> <p>Carrier gas Aprilaire Humidifier</p>	<p>Circa 1990?</p>	<p>Need service contract</p>	<p>Customer will call for contract – check next quarter</p>
	<p>Electrical System</p>	<p>No issues requiring referral</p>		
	<p>Gutters</p>	<p>Clear</p>	<p>Rick's Lawn Service does each fall</p>	
	<p>Roof – system &amp; condition</p>	<p>3-tab composition shingle roof system; appears good</p>
