Safe at Home Repair Evaluation Report

| Age/Description of House: | 1965, split level brick SF w/ decorative porch, den on 1 st floor, laundry room on first floor, bedrooms, kitchen and living areas on 2 nd floor. Clients use front door exclusively (1 st floor). House was restained 9/2011. Generally excellent condition. | Initial Inspection? | Yes |

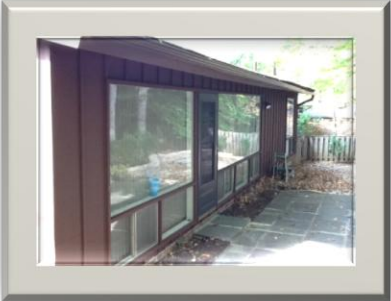
| 5 Rear Entrance | Hand Rails | None | | |

| | Access | 2 steps down to patio | Back entrance rarely used | |
| | Lighting | Needs exterior | Recommend exterior floodlight, switch inside | |

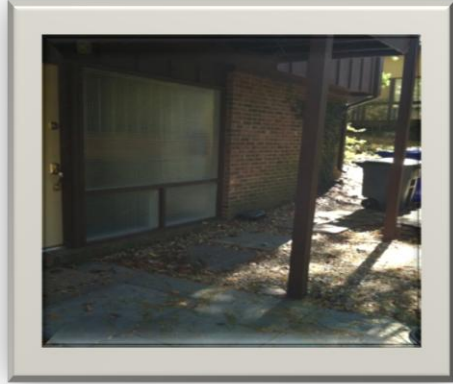
6 TRASHCAN/RECYCLING STORAGE AREA

| | <p>Location, Access is poor</p> <p>Must be wheeled over uneven rocks, flagstone, over raised bed threshold, down steep driveway to grassy area adjacent to driveway, one at a time, every week.</p> | <p>1 large trashcan, 1 large recycling, both wheeled with handles.</p> | <p>Could build 2-walled shed to left of house, alongside den wall. Will eliminate half distance of wheeling full cans. Would need to level floor. But then presents longer walk to eliminate daily trash bags. Further discuss with client.</p> | <p>Discussed with Client – will consider as long-term project</p> |

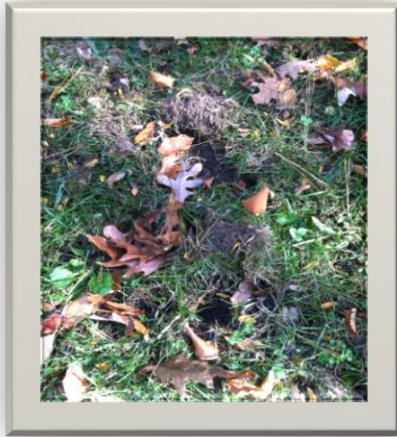
7 Raccoon damage in side yard

| <p>Steep Hill in front yard. Has weekly lawncutting service w/ Rick's Lawn Service, 301-540-4798</p> <p>Neighbor and/or family handles snow removal</p> | <p>Some raccoon damage to side yard, client wants abated asap</p> | <p>Discuss w/ landscaper</p> | <p>Met w/Dale Moyer (Moyer Landscaper) 10/18/11 7:30 am – 10/21 Moyer applied grub killer, aerated. 11/19 most raccoon damage is eliminated. Consider re-sod w/ netting in Spring, will provide proposal to MHC</p> |

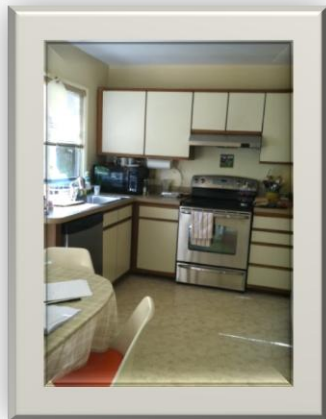
8 Kitchen

| | Lighting | Adequate lighting in task areas | Clean overhead light fixture of bugs | Done at time of inspection |
| | CO Detector – type/location/ battery schedule | | Tested ok, but probably 7+ years old, recommend change now and track | Done 10/17/11 |

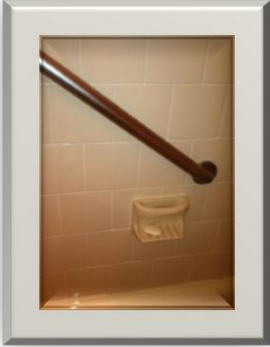
| Bathroom 2 (upstairs) | Throw Rugs? | | Recommend replace existing with rubber backed | Customer will purchase, check next qtr |
| | Drainable Tub Mats | | Need Mat | Customer wants to purchase, check next qtr |

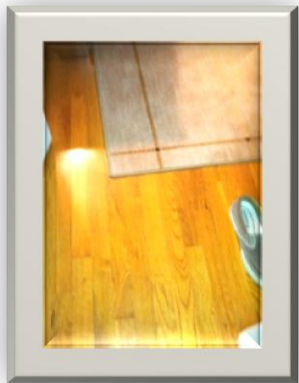
13 Bedroom Rug curling

| | Throw Rugs | Room size rug which may present trip hazard | Advised customer recommend eliminating | |

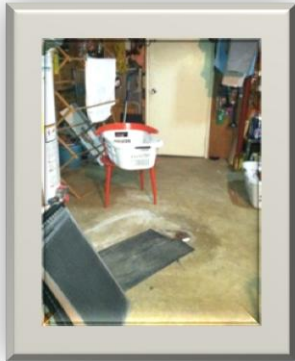
14 Laundry Room

| <p>Condition Generally neat, tidy, but not well lit, and major trip hazard as shown, loose basement doorknob.</p> | | <p>Increase lighting Consider folding table where chair is, store filters away.</p> | <p>Fixed doorknob at time of inspection Client wants to discuss other improvements in spring</p> |

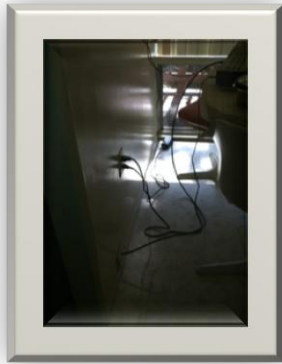
16 Extension cord use in kitchen

| Electric cords | Kitchen needs addressing | Bundle cords, consider moving TV to wall bracket? | Revisit next quarter |

| Extension Cords | Kitchen needs addressing | | |

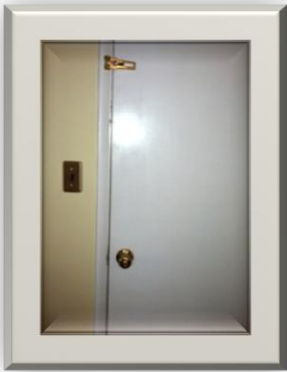
| <p>20 Inside side door</p> | <p>Side Door Locks – type and condition</p> | <p>Good- door rarely used</p> | | |
