Safe at Home Repair Evaluation Report

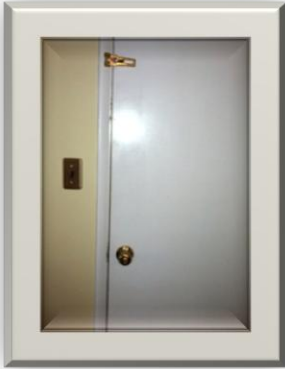
<p>20 Inside side door</p>	<p>Side Door Locks – type and condition</p>	<p>Good- door rarely used</p>		
	<p>Rear Door Locks – type and condition</p>	<p>Same as side door – door rarely used</p>		
	<p>Alarm System? Info:</p>	<p>None</p>		
<p>Systems</p>
