Safe at Home Repair Evaluation Report

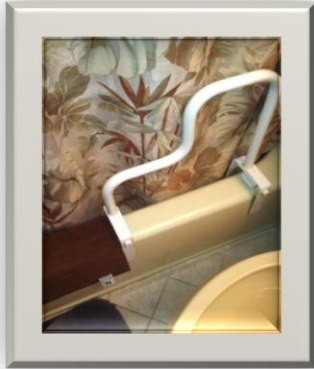
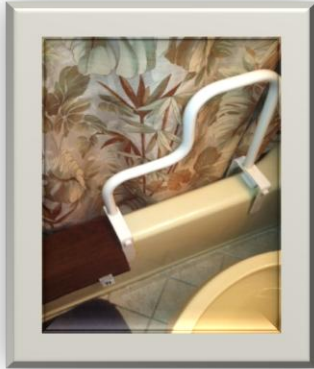
12 2nd upstairs bathroom

<p>12 2nd upstairs bathroom</p>	<p>Grab Bars in and out of bathing area</p>	<p>On far wall and bolted/glued to bathtub edge – client does use</p>	<p>Recommend install vertical bar leading into tub</p>	<p>Discuss again next qtr</p>
	<p>Condition of Fixtures</p>	<p>New</p>		
	<p>Anti-Scald mixers?</p>			
<p>MASTER BEDROOM</p>				
	<p>Throw Rugs?</p>	<p>Rubber backed ok</p>		
	<p>Transition pathway clear?</p>	<p>Clutter near doorway</p>	<p>Eliminate storage of shoes between bedroom and bathroom</p>	<p>Done 10/27/11</p>
	<p>Height of closet rods/shelves</p>	<p>Not an issue</p>		
	<p>Height of bed?</p>	<p>Ok</p>		
	<p>Clothes hooks</p>	<p>Yes and being used</p>

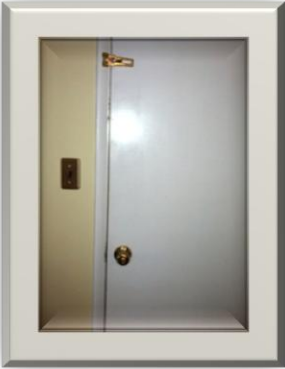
<p>Side Door Locks – type and condition</p>	<p>Good- door rarely used</p>	
<p>20 Inside side door</p>		<p>Rear Door Locks – type and condition</p>	<p>Same as side door – door rarely used</p>	
		<p>Alarm System? Info:</p>	<p>None</p>	
<p>Systems</p>
